Procedia - Social and Behavioral Sciences 85 (2013) 574 – 581

AcE-Bs 2013 Hanoi

Preservation and Recycling of Heritage Buildings in Malacca

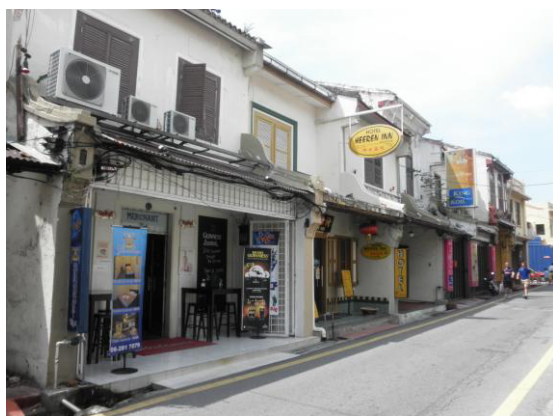
It was found that the physical aspects and the current function of several buildings along the street keep evolving. There were always buildings under renovation. The buildings that were in full use at a certain time were found to be otherwise later. For instance, the building at number 36 was used as Ginger Flower Boutique Hotel. Then, in December 2012 the hotel had moved to a new renovated building at number 13 along the same street. On the whole, the boundaries of each building still follow the narrow elongated plots as in the earlier period. The changes that took place were either on the facade, interior or the back. The majority of the houses had increased in floor to floor height. This was obviously visible when compared with the low height of the early Dutch houses. One way or the other, the street still retained its character as an area for accommodation whereby the street was narrow and included a narrow private *verandah* (Fig. 1a).

Fig. 1. (a) Buildings along the study area; (b) A house along the street

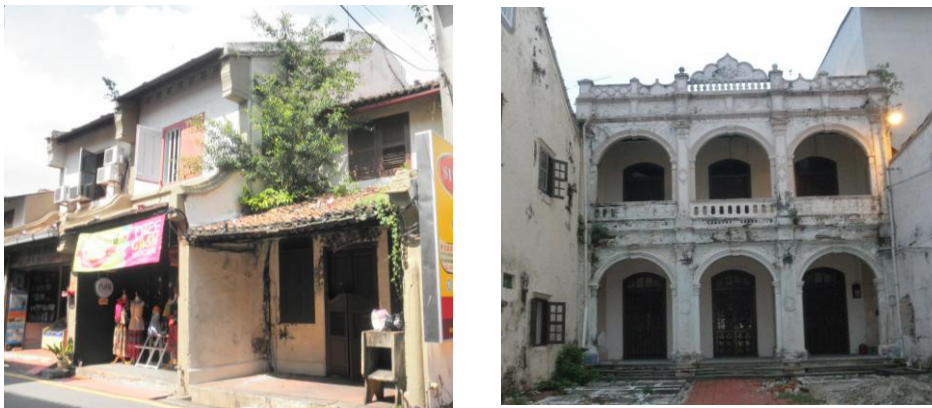
Quite a large number (27, 15.25%) of the houses are not being used and some looked abandoned. An example of a house in a very poor condition is at number 22 (Figure 2a). It has the early form of the Dutch period that could be easily noticed by the low height and simple form. According to the research done by Raja Nafida (2008) there were only 291 early Dutch houses found in the core zone. Out of that 112 of them still retain the form and the interior of the early forms. There were 82 units of these early Dutch houses along the street. These buildings are important examples of the Dutch period and also as examples of the different layers of the colonial powers in the history of Malacca. Thus, these buildings should be maintained.

There were two big houses that were recessed from the street. The first was Tun Tan Cheng Lock House at numbers 117 to 119 and the other at numbers 133 to 135. Tun Tan Cheng Lock House (Nos. 117-119) with its elegant character looks well maintained. The second house (Nos. 133-135) was also beautifully built and architecturally pleasing but clearly neglected (Figure 2b). It is a pity if it remains to be in the present condition and leave to rot.

Fig. 2. (a) An abandoned early Dutch house; (b) A beautiful but neglected building
